South Receive Site Antenna Replacement

Tom Bosscher K8TB April 1, 2012

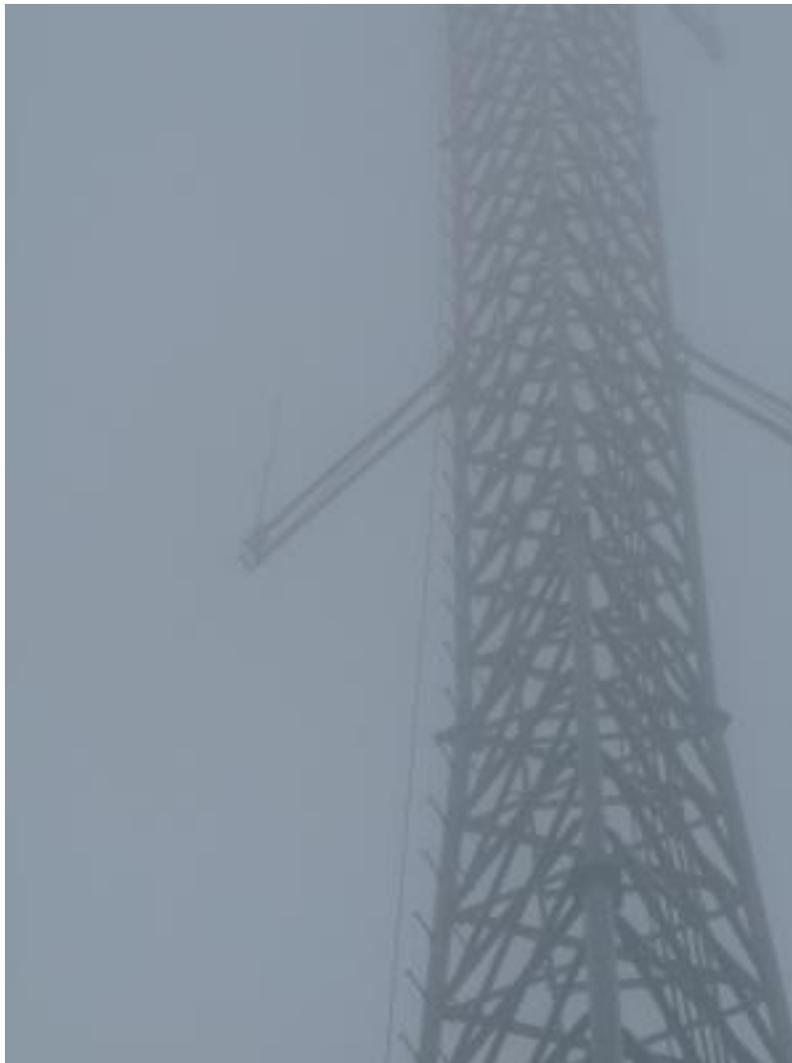
This is a zoomed in picture of our defective antenna.

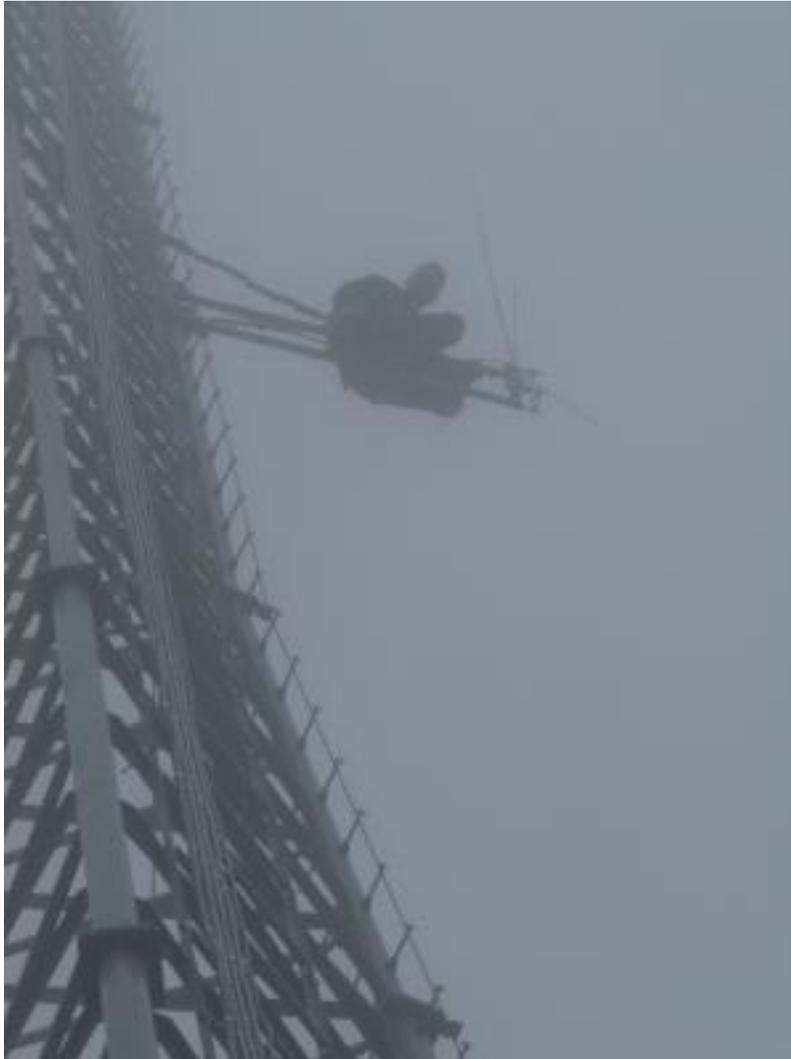
Tower crew out on the ledge, taking down the defective antenna.

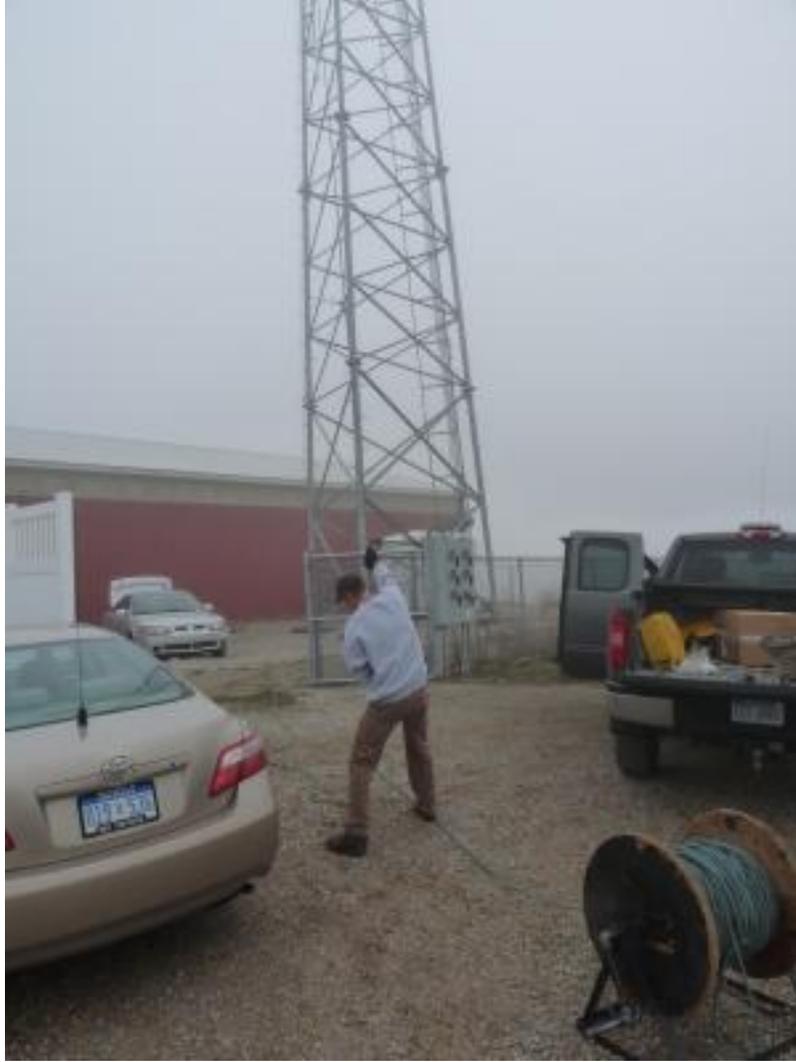
Tower crew bolting in the antenna.

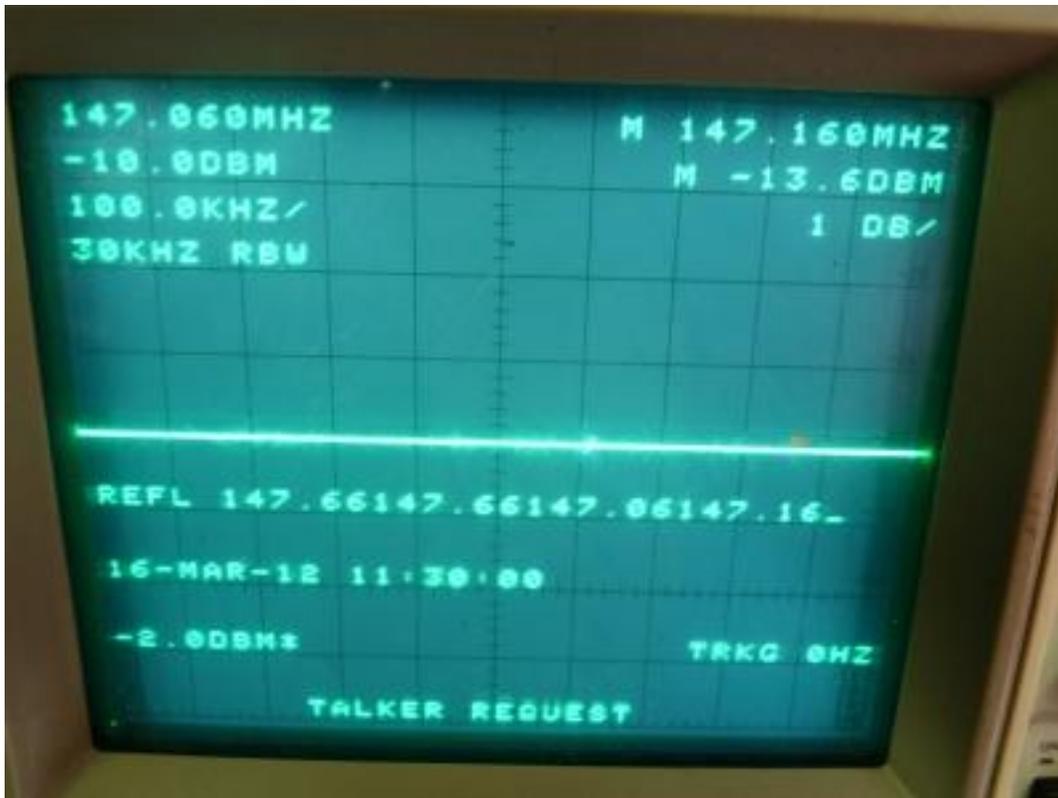
This is a picture of the feed line terminated with a 50 ohm load. A measurement of -40.6, a return loss of 27 db, or a VSWR of 1.09:1

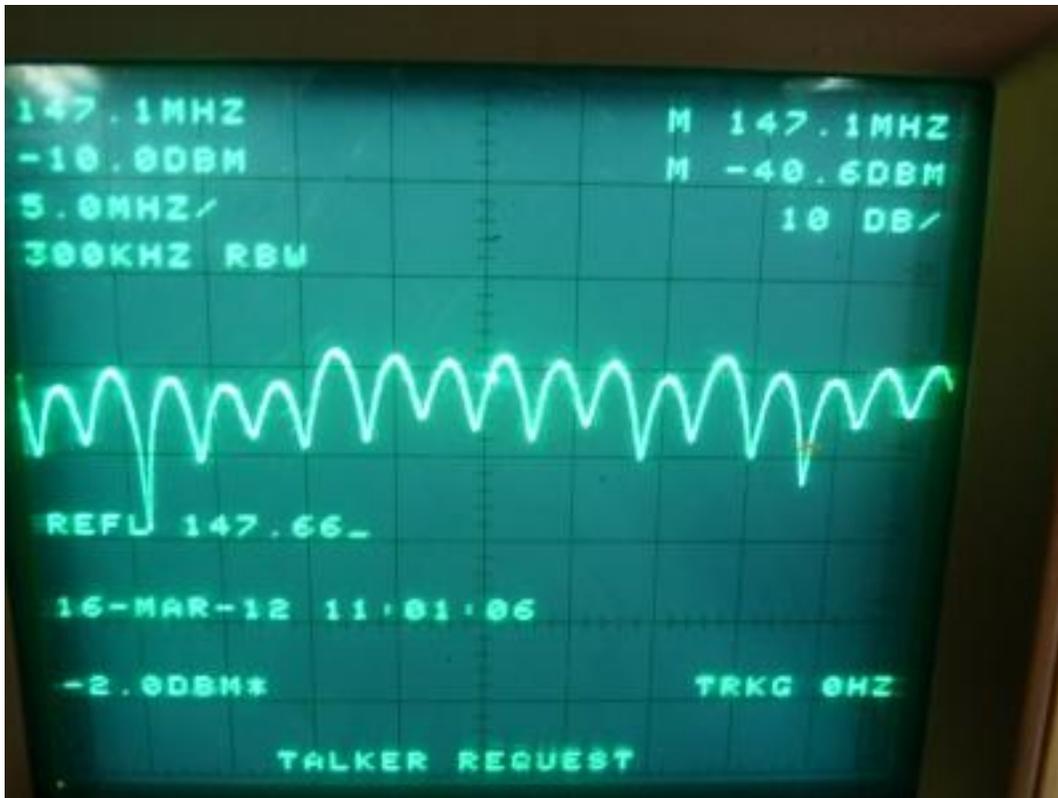
This is a picture of the feedline unterminated. It shows a reading of -16.1 DBm, which is the feed line loss, times two, from -13.6. This comes to 2.5 divided by 2, or 1.25 Db for the line, which is very good.

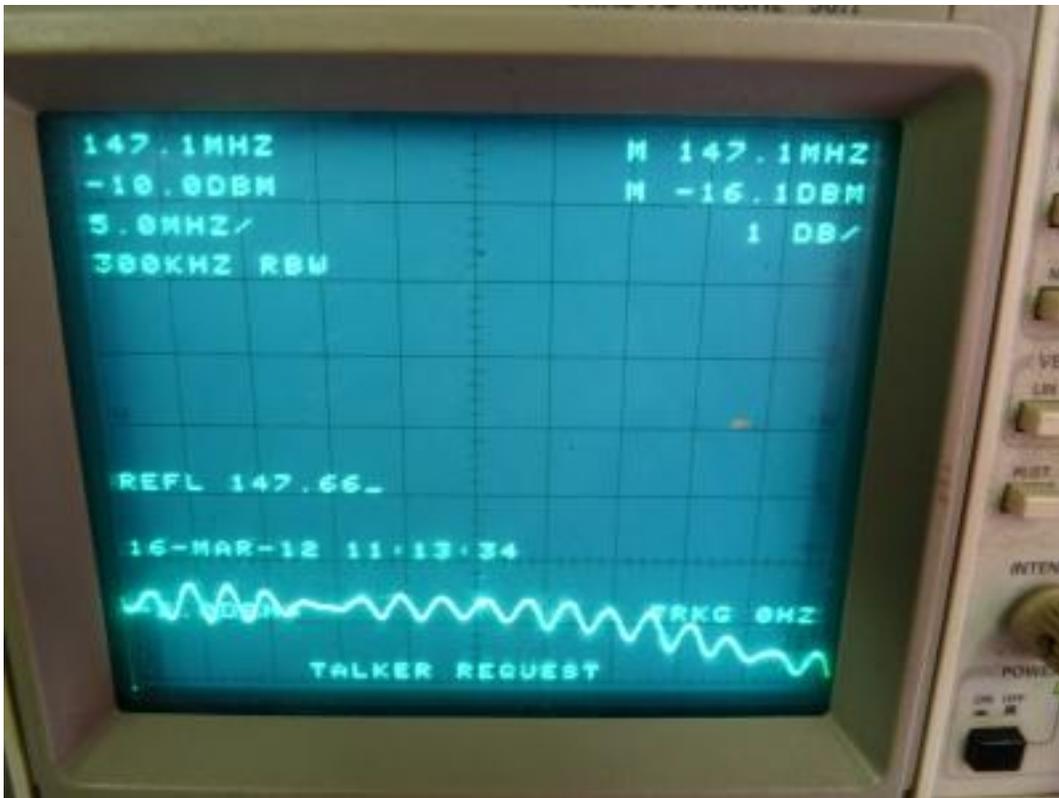
This is the new antenna, showing a return loss of 20.3 DB, (33.9 minus 13.6 reference).

This is the same as a VSWR of 1.21 to 1.

So the new antenna is in place. Laryn and I measured a 24 Db increase in signal level to the feed point at the ground, using the 147.06 and 147.16 repeaters for references. The APRS node is now hearing Wisconsin stations.
